MEMO FOR RECORD

SUBJECT: Kennebec and Sebasticook Rivers ice conditions and installation of Kennebec River ice motion detectors, 25-25 Feb. 2004

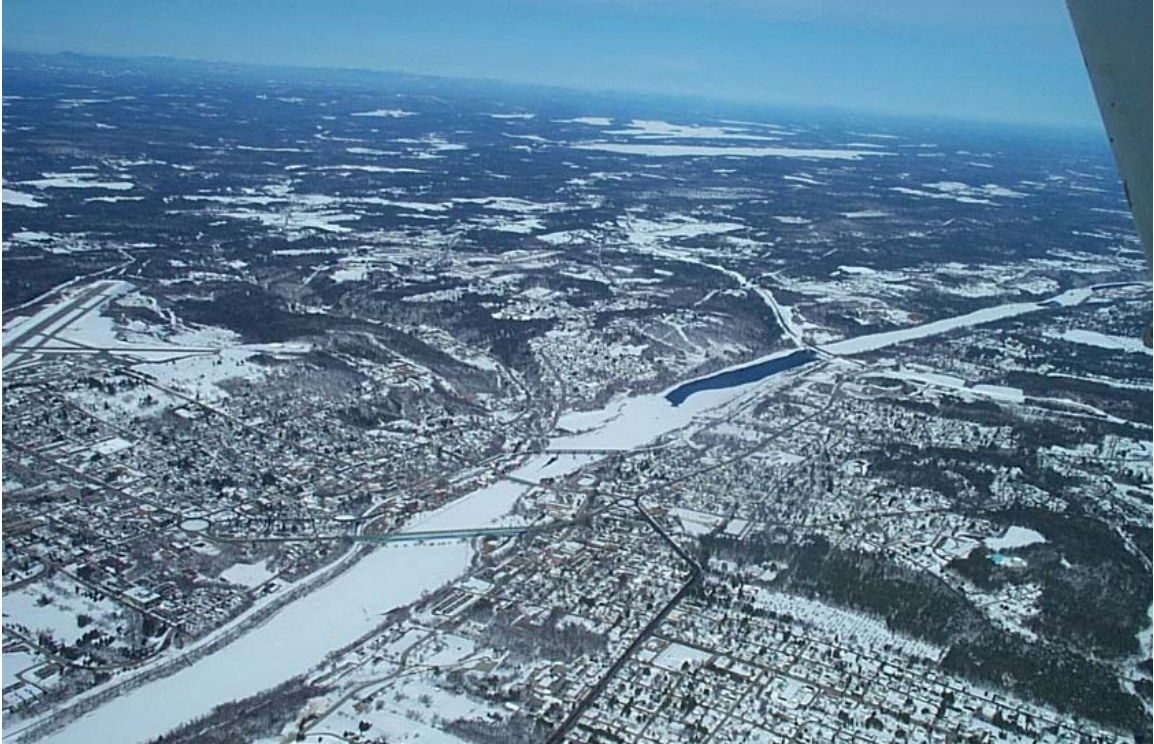
Fig. 1. Kennebec River at Augusta on 25 Feb. 2004 showing open lead downstream of new Third Bridge.

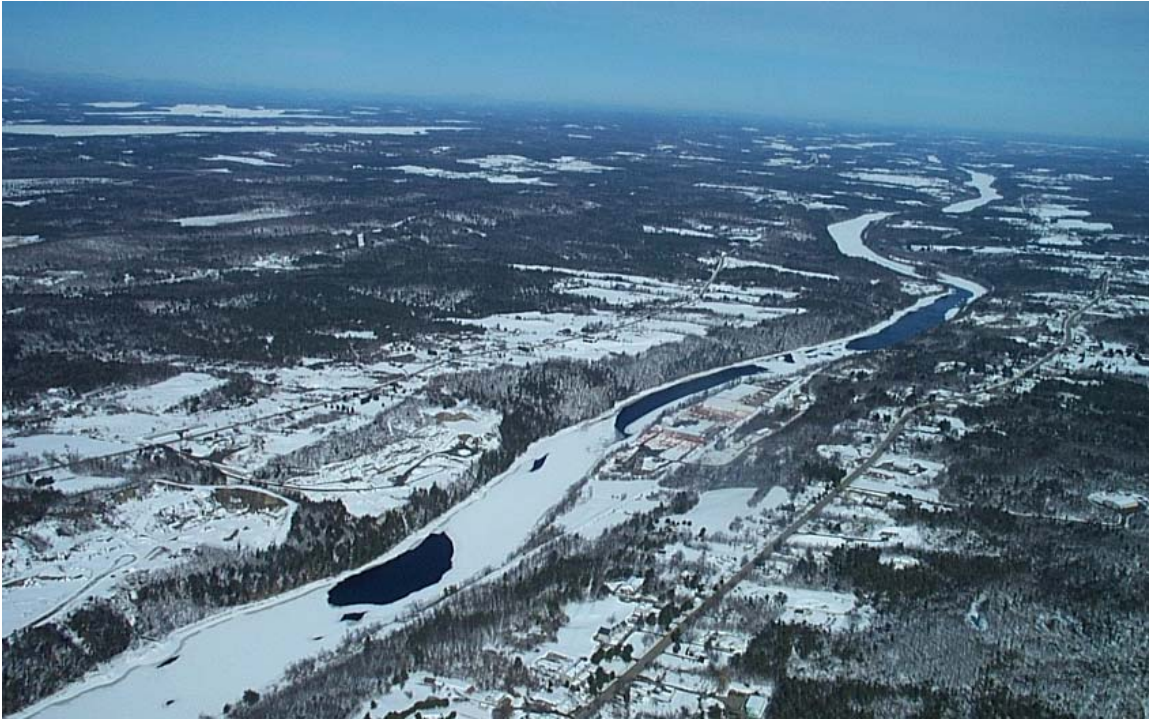
Fig. 3. Kennebec River upstream of Augusta, showing open leads in the vicinity of North Country Food Service.

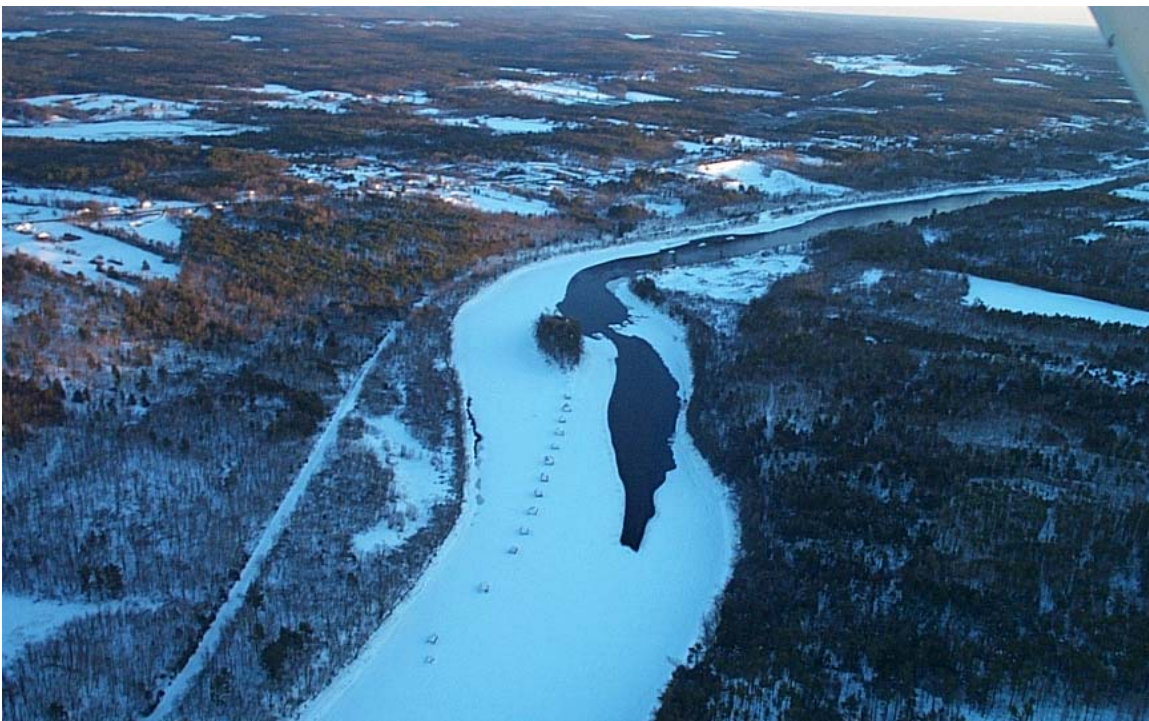
Fig. 5. Looking downstream through "the rips", a fast-moving section of the Kennebec about 5 miles upstream of Augusta.

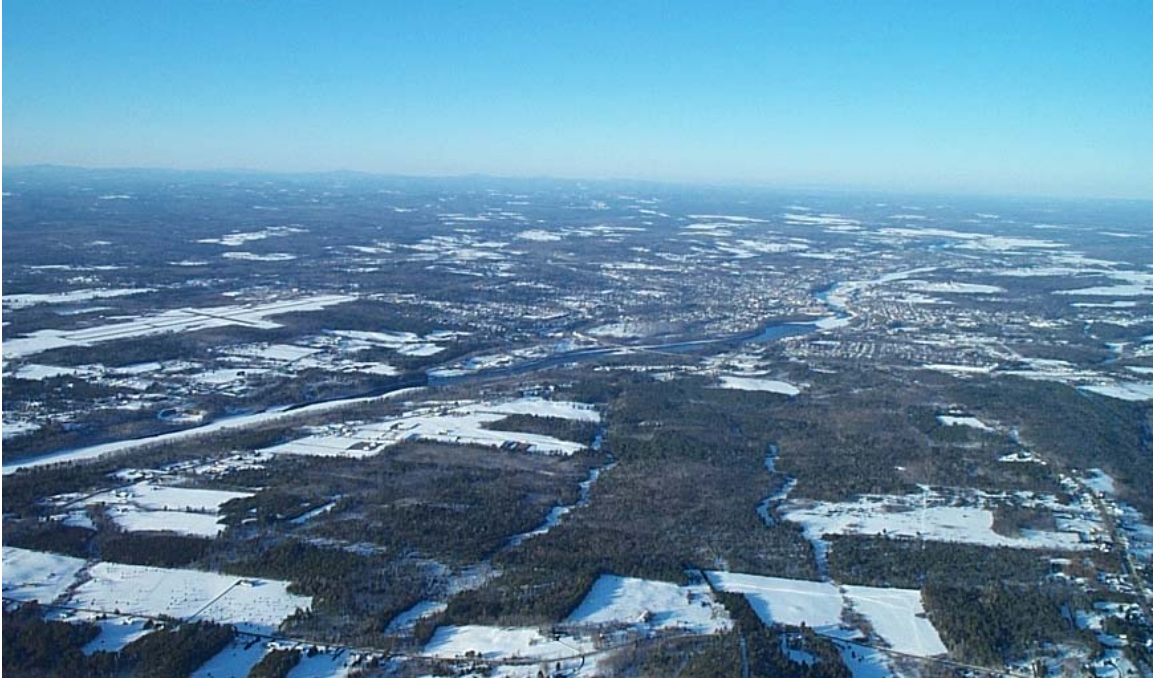
Fig. 6. Kennebec River on 25 Feb. 2004 showing open water extending for about 2 miles below Waterville.

On 25 Feb., the ice cover on the Kennebec extended from Merrymeeting Bay upstream through Augusta to a point about 2 miles below Waterville. At Augusta, the textured ice surface from the freezeup ice jam of 8 Jan. was still evident beneath 10 inches of new snow that had fallen 5 days previously. Above the jam, a 1/2-mile-long open section extended from the site of the former Edwards Dam upstream to the new Third Bridge, which is under construction (Figs. 1 & 2). The temporary work barges moored between the bridge piers had caused an ice cover to form upstream of the bridge and an open lead to remain downstream. Between the Third Bridge and the bend 5 miles above Augusta known as "the rips", several open leads remained in the vicinity on North Country Food Services (Figs. 3 and 4). A nearly uninterrupted ice cover extended from just above the rips, to a location about 2 miles below Waterville, near the mouth of Messalonskee Stream (Fig. 5). A narrow, half-mile long lead was visible just downstream on the North Sydney USGS Gage. Within the 2-mile-long open stretch below Waterville, a small area of ice surrounded the piers of the Donald Carter Bridge, and ice covered Teconic Bay between the mouth of the Sebasticook and the faster flowing water immediately below the Lockwood Dam (Fig. 6). Above the Lockwood Dam, the Kennebec was mostly ice covered for about 2.5 miles to the railroad bridge at Farifield, and then open for about 3 miles up to the dam at Shawmut. Above Shawmut, the river was mostly ice covered for about 25 miles to a point about 2 miles below Madison near the mouth of the Sandy River. The Kennebec was again ice covered from the dam at Madison to a point about 5 miles below the dam at Bingham.

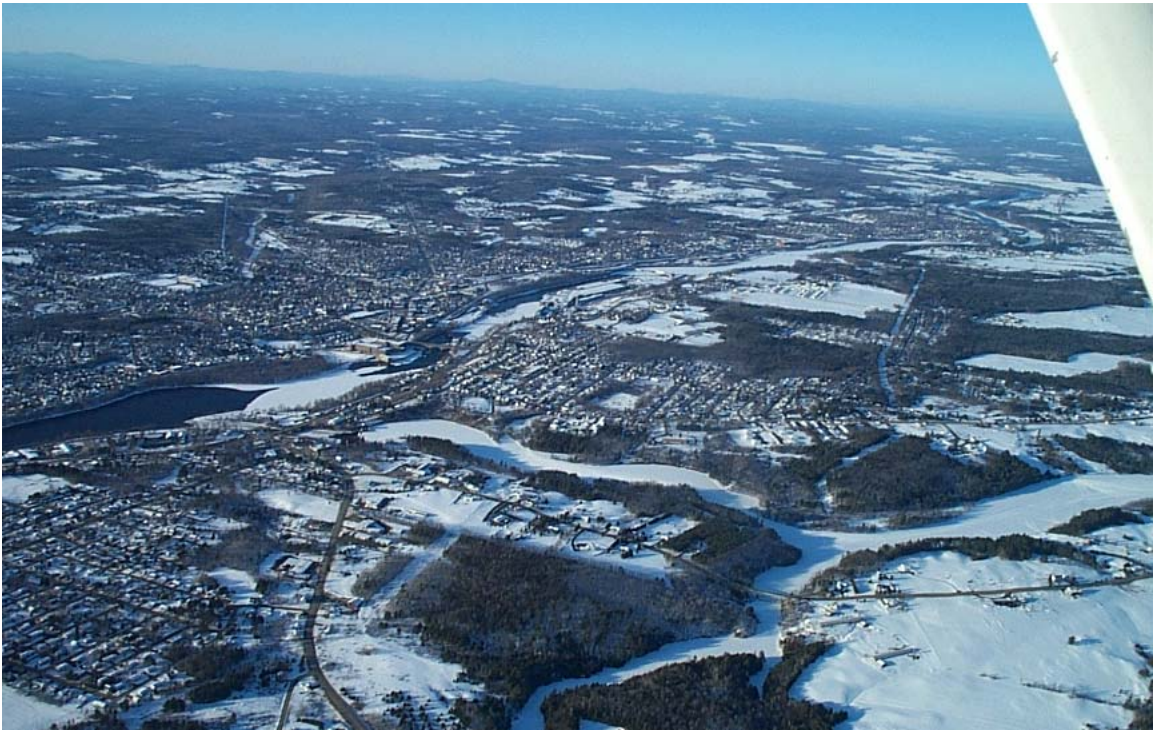
Fig. 7. Sebasticook River entering the Kennebec at Winslow/Waterville

The Sebastocook River was completely ice covered from the Ft. Fairfield Dam upstream to a 2000-ft-long open lead below the Benton Dam (Figs, 7 and 8). Above Benton, the Sebasticook the ice cover continued north as far as was visible. Below the Ft. Fairfield Dam, the Sebastcook was covered in newer gray ice that began forming in late January.

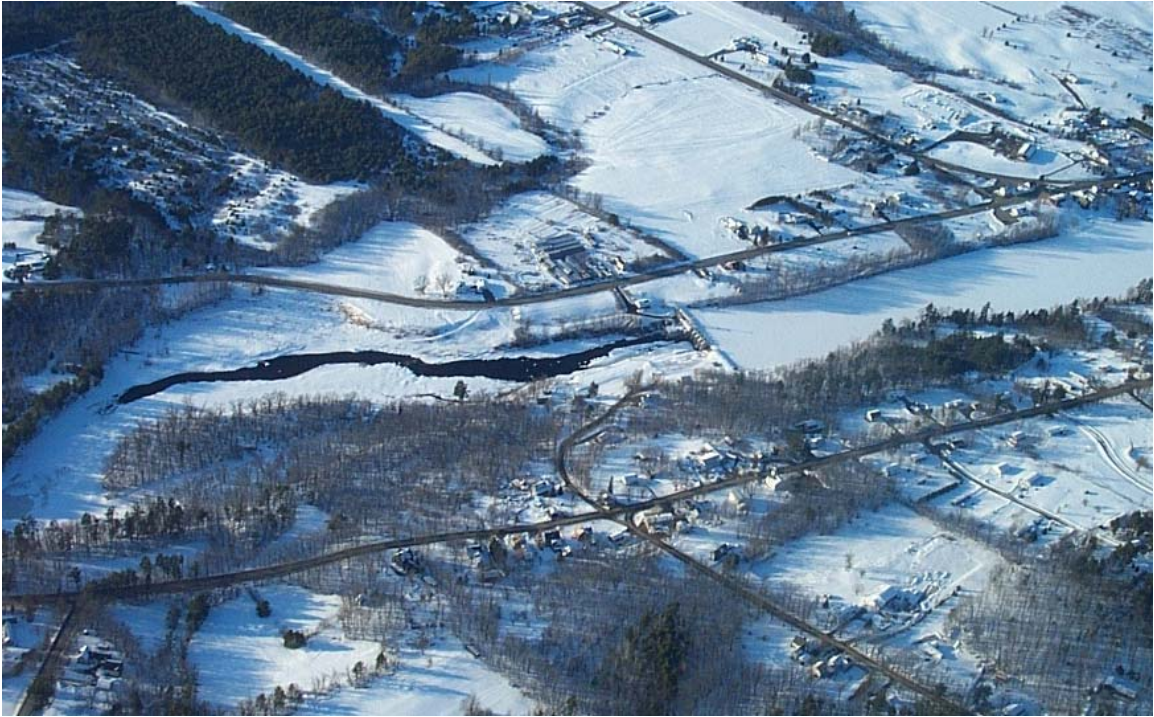
Fig. 8. Open lead below Benton Dam.

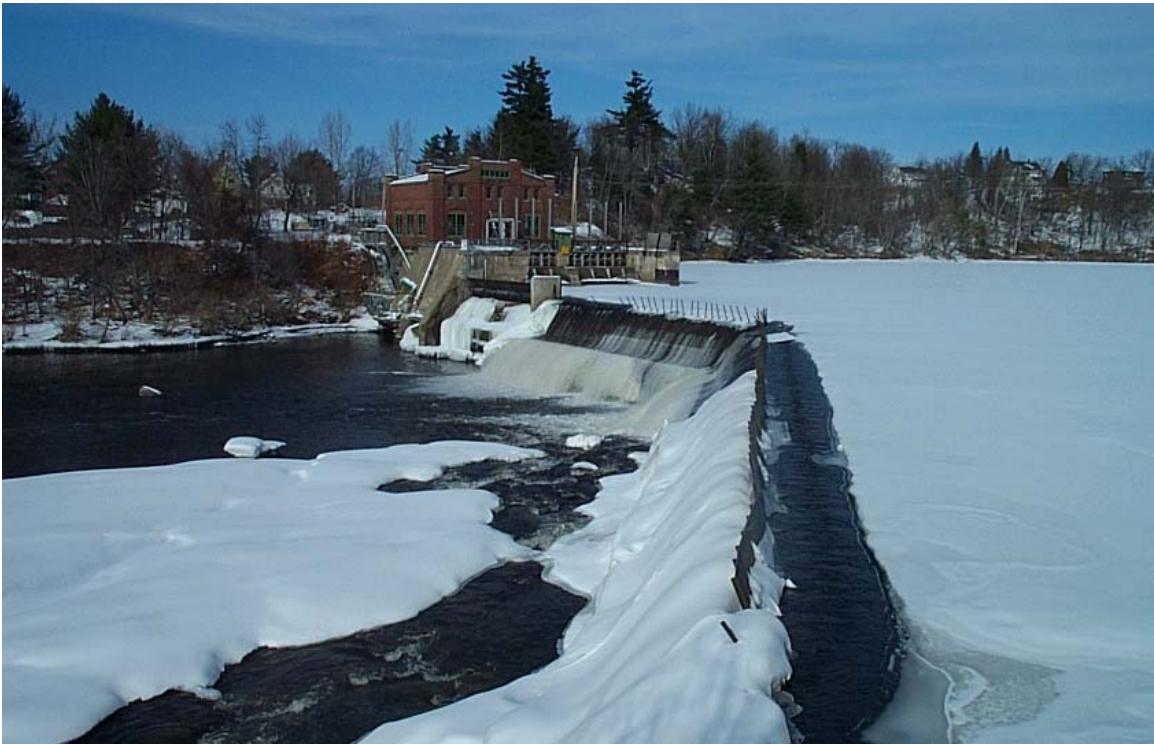
Fig. 9. Ft. Halifax Dam

We inspected the Ft. Fairfield Dam, which was passing flow over the central part of the spillway crest with no flow through the powerhouse (Fig. 9). The flashboards were not in use having not been repaired since damaged during previous ice breakups. We also visited the Lockwood Dam and powerhouse, inspected the ice cover on Teconic Bay and went to the site of the new Third Bridge.

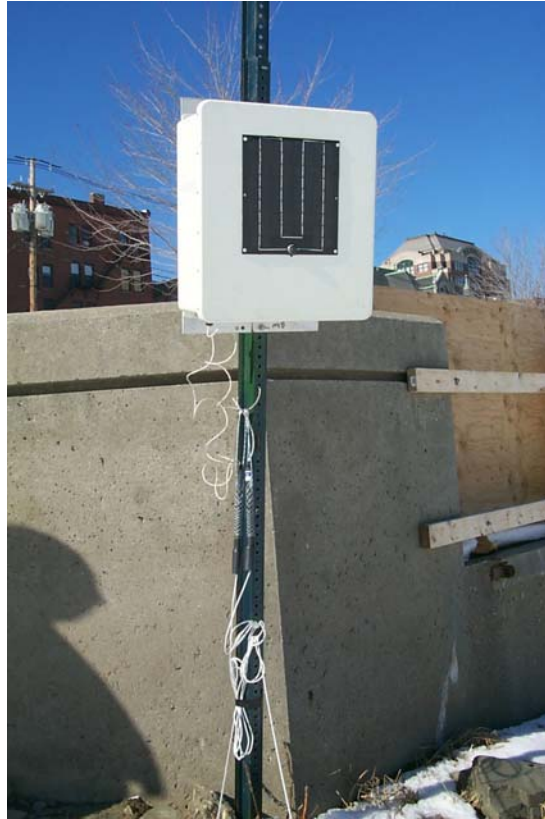
Fig. 10. Ice motion detector near Maine State Housing in Augusta.

On the morning of 26 Feb, I met with Andy Straz of E/PRO to discuss the status of the Ft. Halifax Dam Removal Study. Later, I met with Chris Williams and Tommie Hall and helped install the ice motion detectors. At the first ice motion detector site in Augusta, just upstream of Maine State Housing Authority, the ice was 32 and 28 inches thick, 70 and 400 ft out from the west shore respectively. The cover was rough due to its freezeup ice jam origin. We found a significant amount of frazil slush beneath the solid ice in each hole. Fig. 10 shows the ice motion detector in Augusta.

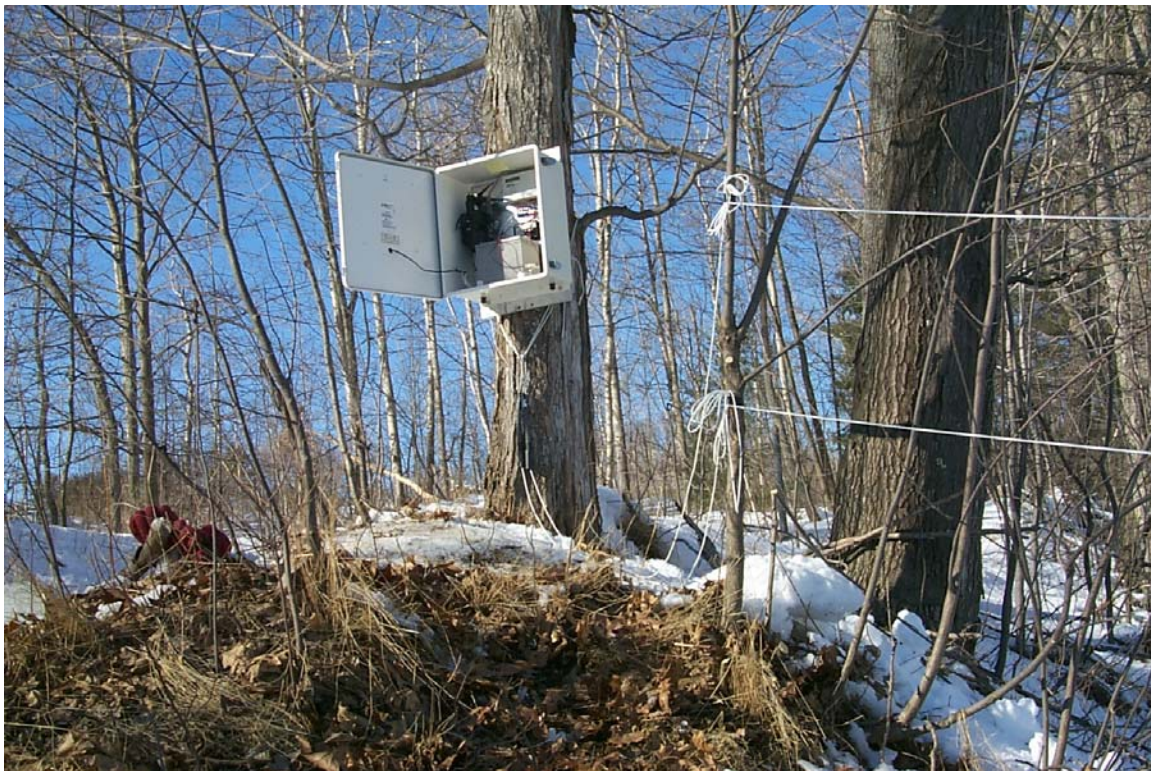
Fig. 11 Ice motion detector at the Sydney boat launch.

We installed the second ice motion detector at the Sidney boat launch, about 9 river miles upstream of Augusta (Fig. 11). Here the ice was 20-inches-thick 50 ft out from the west

shore and 24-inches-thick 150 ft out from the shore. The ice was mostly white, indicating a frazil or snow origin. No slush ice was found beneath the solid ice cover. Ice rubble remained piled on the banks to a height of about 8 ft. as the result of the 17-18 Dec. 2003 thaw that broke up many rivers in Maine.
